## Reference Case: Success Story

# Mold Matching System Tyre Industry

("Smart Curing. Superior Uniformity. Enhanced Productivity")

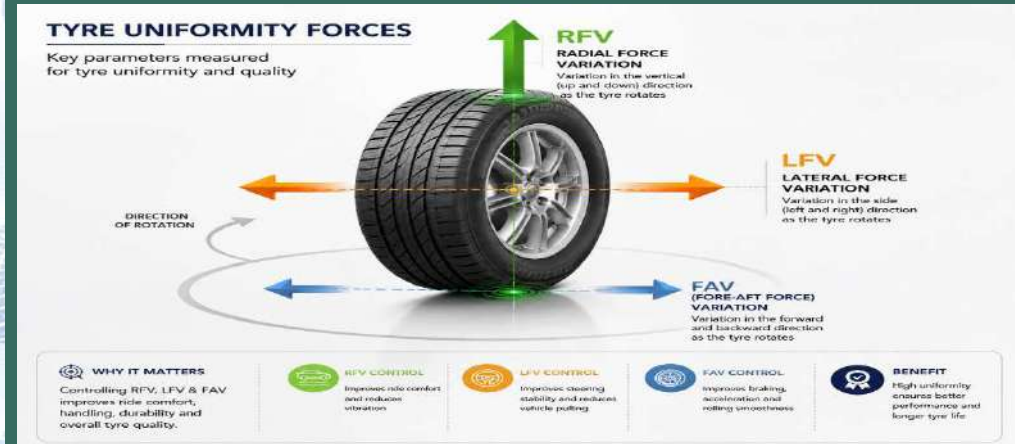
The Mold Matching Project automates tyre curing by analyzing RFV/LFV uniformity values and intelligently selecting the optimal curing angle. Through seamless integration of the Building Machine, Uniformity Inspection System, and Curing Machine, the solution enhances tyre quality, reduces defects, and improves manufacturing efficiency.

The solution integrates the **Building Machine**, **Uniformity Inspection System**, and **Curing Machine** through a centralized **Mold Matching Server**, enabling seamless data exchange and real-time decision-making. Based on tyre uniformity measurements, the system calculates and transmits the appropriate curing angle to the curing machine, eliminating

Developed a centralized **Mold Matching System** that integrates the **Building Machine**, **Uniformity Inspection System**, and **Curing Machine**. The solution automatically analyzes **RFV/LFV** values, determines the optimal curing angle, and transmits it to the curing machine in real time, ensuring accurate mold matching and consistent tyre quality.
